R410A

Commercial Air Conditioners

# Technical Service Manual

## Quantum Series (AU)

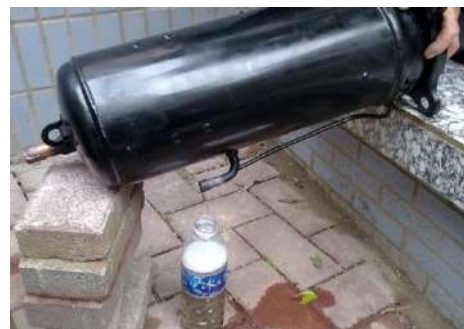
Figure 6-2.5: Draining oil from a compressor

#### Step 2: Inspect oil from faulty compressor

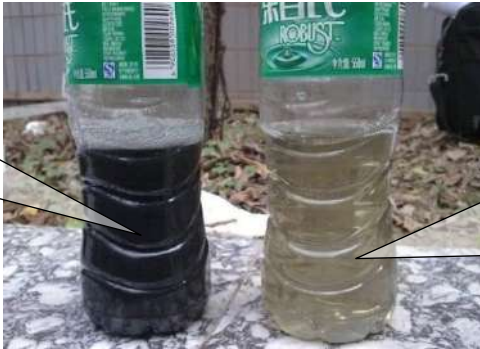
This oil is black  
- it has been  
carbonized
